Flight Service Evaluation of Kevlar-49 Epoxy Composite Panels in Wide-bodied Commercial Transport Aircraft

Sixth Annual Flight Service Report

R. H. Stone

LOCKHEED-CALIFORNIA COMPANY
BURBANK, CALIFORNIA

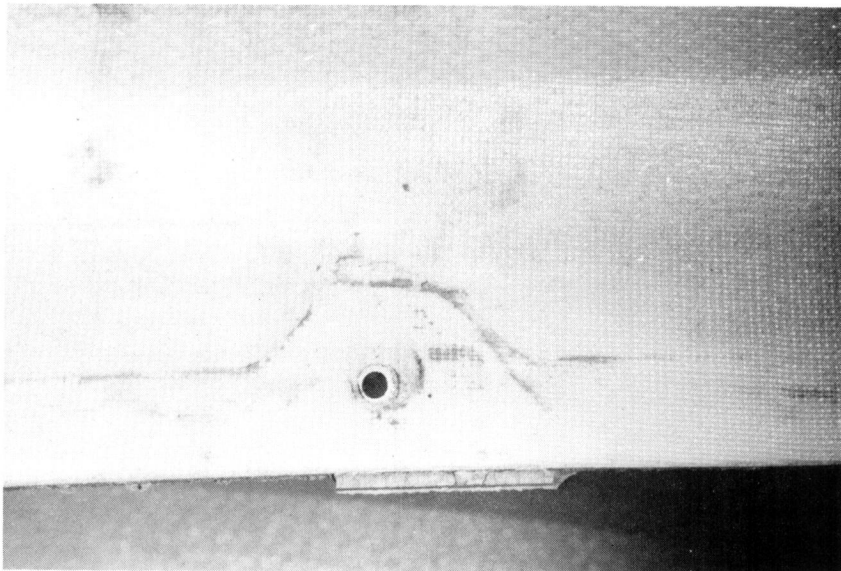
Figure 7. - Air Canada fiberglass wing-body fairing - typical fastener hole.

A fiberglass wing-body fairing had been removed and was available for inspection. For comparison, a typical fastener hole is shown in Figure 7. No damage or hole elongation was observed on this panel.
